# DOWN ROAD DRILL HALL BEXHILL-ON-SEA, EAST SUSSEX HISTORIC BUILDING RECORD AND HERITAGE ASSESSMENT

TEP
No. 1 The Chambers,
Bowden Business Village,
Market Harborough,
Leicestershire,
LE16 7SA

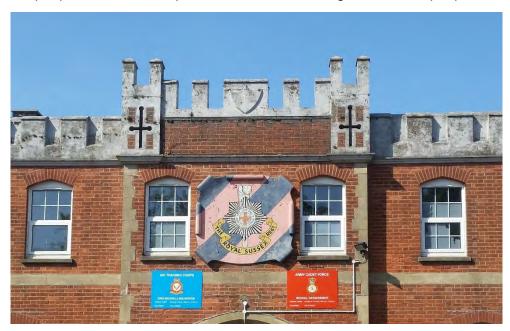
Figure 2: Shield decoration and plaster flag on principal elevation, facing north

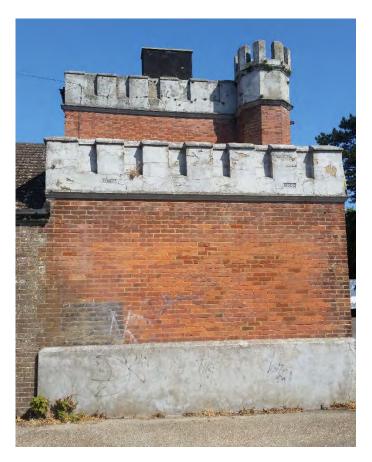
Figure 6: West elevation of main two-storey office block, looking east

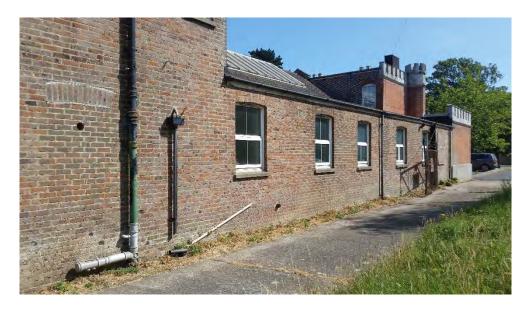
Figure 7: The brown brick west elevation to the main hall, to the rear of the red brick frontage, looking south east

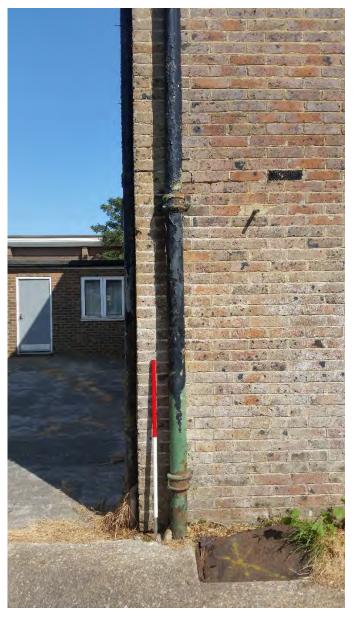
Figure 9: Guttering on the west elevation, showing original painted pipework and metal ventilation brick to the right, looking east

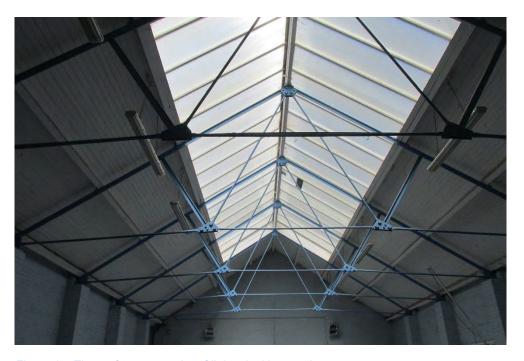
Figure 17: The roof trusses and roof lights, looking south

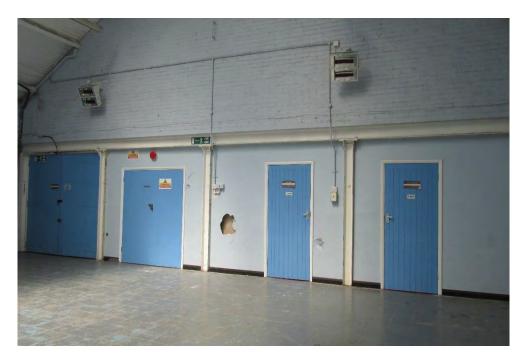
Figure 21: The northern elevation, showing four bays with west original doorway and later door addition with plaster board, looking north

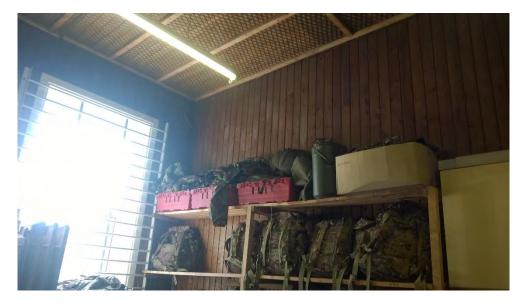
Figure 24: The panelled walls and ceiling of the store/saddle room

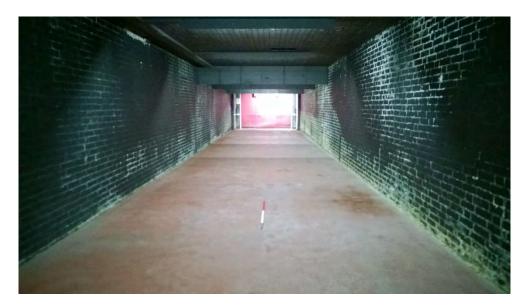
Figure 32: Looking down the rifle range, toward target, looking north. Some water damage to east wall seen here
