Gladman Developments Ltd

**Land off Fryatts Way, Bexhill-on-Sea**

**Arboricultural Assessment**

June 2021

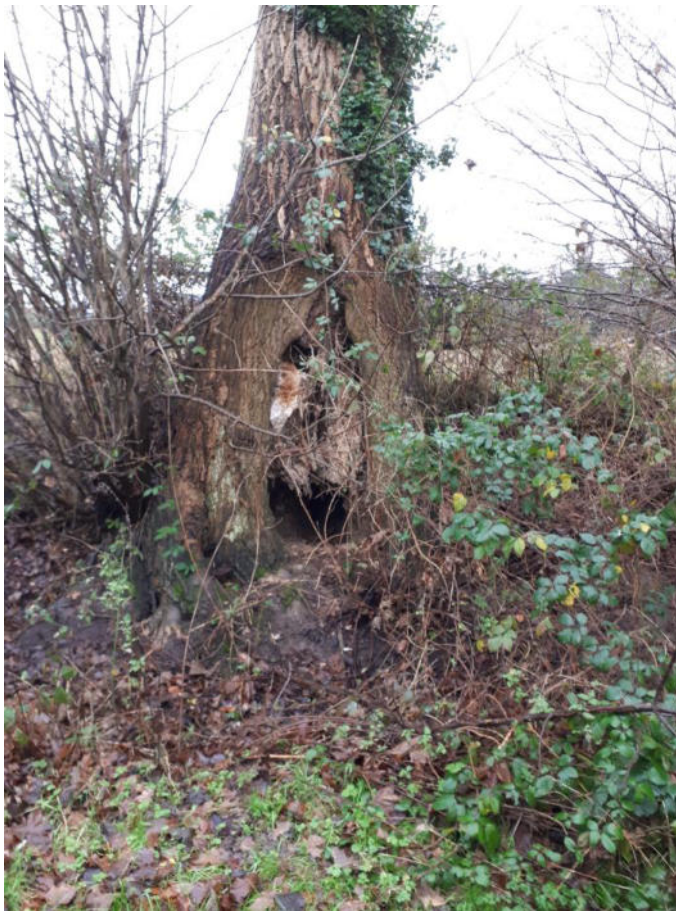
- 4.16 Two groups, G7 and G8, were deemed to merit a Category U – unsuitable on arboricultural grounds – classification. Both groups contained over mature hybrid black poplar displaying varied condition, though arboriculturally none were in anything but poor condition. Of note was a single tree in G8 with a significant amount of decay and hollowing at the base. See Photograph 1 below.

**Photograph 1: Image showing evidence of a significant cavity and hollowing at base of c.35m tall hybrid black poplar recorded within G8.**

- 4.17 The wood of this cultivar is relatively soft, and therefore not particularly durable. This is caused by the fast-growing nature of the species, which is achieved at the deficit of strength. Given the dimensions of these trees (c.35m high/stem diameters up to 1100mm) the forces acting upon the

wood are likely to be high. There would therefore be an increased risk of failure associated with these trees.

- 5.8 The poor state of G7 and G8 have been discussed in detail above. The removal of both groups is therefore recommended in line with sound arboricultural practice and under the Land Owner's Duty of Care. As such, their removal should be considered separate to the development and not be considered a constraint to the proposals.

classification – unsuitable for retention. Both G7 and G8 were formed from over mature hybrid black poplar which stood to a height of up to 35m. Given the poor condition of these trees, their large size, and the characteristics of the wood for this species the removal of both G7 and G8 should be prioritised.
